CRASH INJURY INVESTIGATION

U. S. ARMY HU-1A

BELL IROQUOIS HELICOPTER ACCIDENT

U.S. ARMY HU-1A BELL IROQUOIS HELICOPTER ACCIDENT
Fort Carson, Colorado
9 June 1960

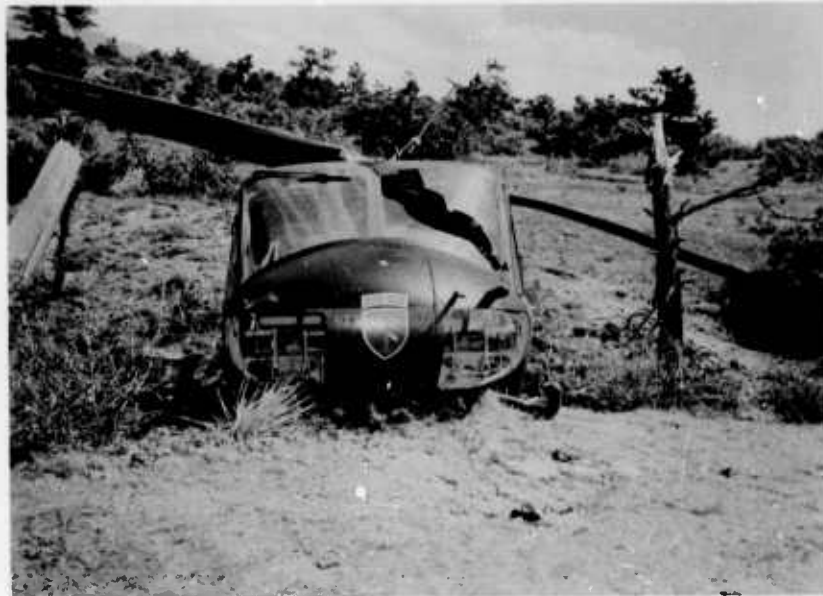
Figure 4. Front view of the helicopter showing broken plexiglas in both pedal wells and left windshield. Destruction of the main rotor is clearly shown.

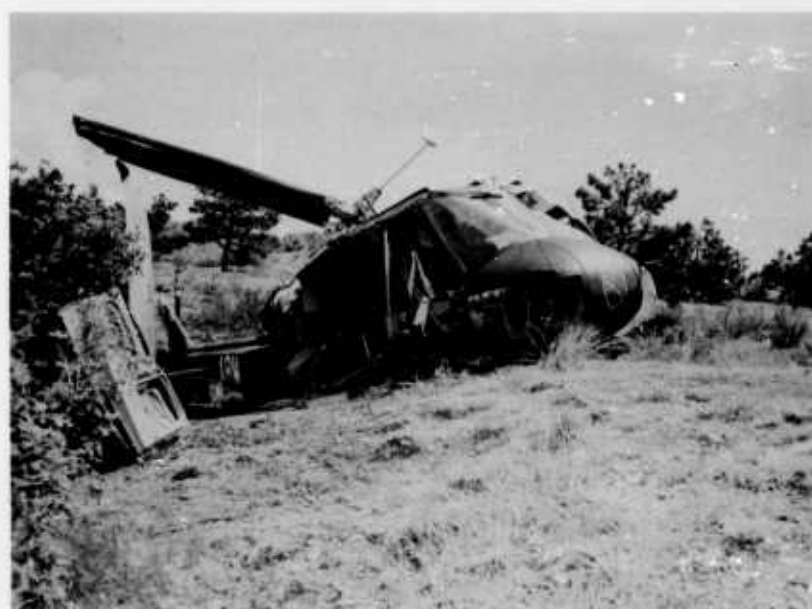
Figure 6. Right front view of the helicopter. Note the distorted right skid.

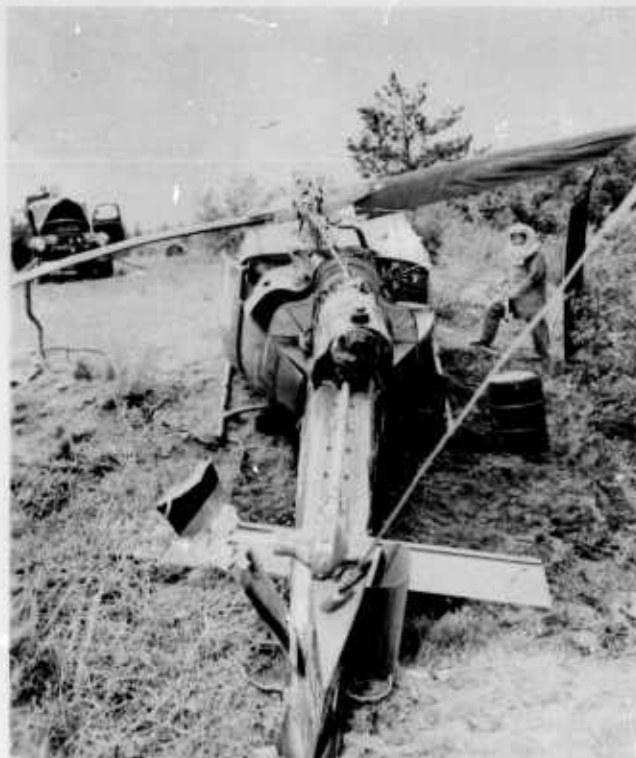
Figure 7. Rear view of helicopter showing demolished rotors and twisted tail boom.

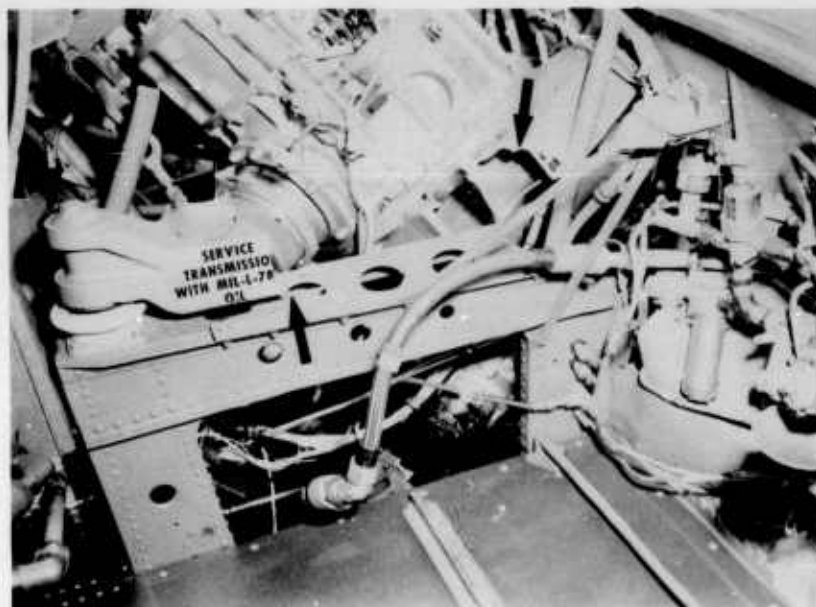
The transmission assembly failed in this accident in the same manner as experienced in previous HU-1A accidents. The significant failure point in all HU-1A accidents is the magnesium casting which serves as a cradle supporting the transmission assembly. In this instance, the transmission moved forward and was, therefore, a contributing factor insofar as injuries are concerned. This is a hazard which has been pointed out on several occasions. During a recent evaluation of the HU-1D helicopter, it was found that Bell Aircraft was providing for a fifth transmission mount to prevent the transmission from moving forward during a crash. It is questionable, however, whether this will resolve the problem because the failures have not occurred at the mounts, but rather in the magnesium casting which serves as a cradle for the transmission assembly. The failure experienced in this accident is shown in Figure 8.

Figure 8. Note the fractures in the magnesium casting (arrows).

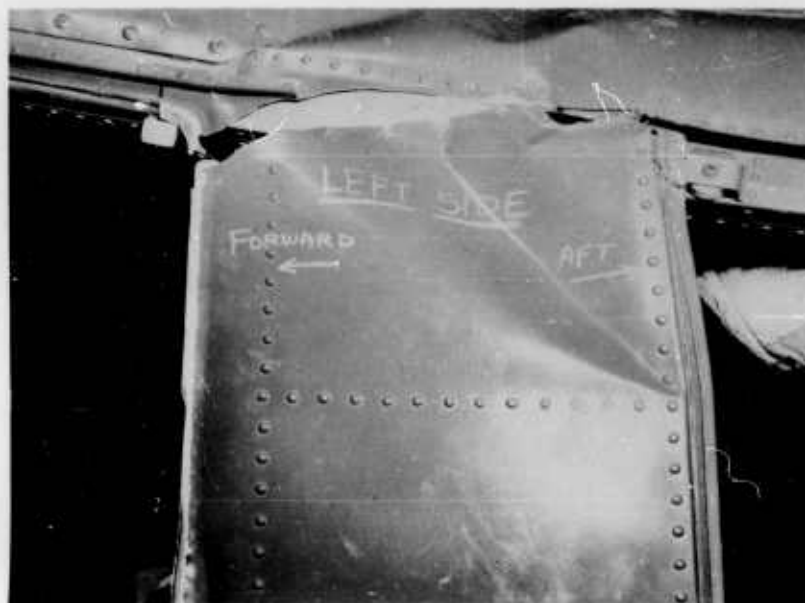
Failure of these support members in this and four other HU-1A accidents reported indicates an inherent structural weakness and stresses the need for redesign to eliminate this potentially dangerous crash injury hazard.

Figure 9. Side view showing failure of left vertical support at upper attachment and shifting of overhead cabin structure.

"RFA #11 requested that the contractor study the aft cabin bulkhead to improve the structure. As a result of these studies, the contractor is of the opinion that the most logical approach to improving the strength of this bulkhead would be to change the structure above W.L. 54 to a honeycomb type structure. In order to effect this change, it would be necessary to make extensive tooling changes, such as fabrication of a bonding fixture, and to re-engineer the mounting of those items such as hydraulic and electrical equipment which are attached to the bulkhead. By changing the sheet metal structure to honeycomb type construction, the pure vertical load carrying capability of the bulkhead would be increased from 14,900 lbs. to 35,000 lbs. It should be noted that these are comparative figures only and do not take into account lateral or fore and aft displacement of the bulkhead under crash loading conditions. Displacement of the bulkhead would materially reduce the vertical load capability of the bulkhead; therefore, the true crash load capabilities of the bulkhead cannot be calculated.

RFA #12 requested that the contractor study the problem of adding vertical support members to prevent collapse of the roof structure upon occupants during a crash landing of survivable "G" forces. As a result of these studies, it is the opinion of the contractor that the most logical approach would be one of making a general increase of gauge thickness of the sheet metal structure of the door post to increase its column load capabilities. The weight increases per helicopter would be approximately 3.5 lbs. The column strength would increase from 1750 lbs. to 2690 lbs. per door post for a total increase in strength of approximately 54%. This change could be accomplished on production HU-1B's and does not involve serious tooling problems. A second approach which the contractor investigated was the addition of roll-over structure to the pilot and copilot seats. This change would add approximately 3.5 lbs. per helicopter and would provide structure capable of withstanding a vertical load of 3500 lbs. per seat. This change could be incorporated into production aircraft or retrofitted to aircraft already built with changes to the seat assembly."

submitted under RFA #11 has also been approved and that the new rear support member is being incorporated in HU-1B helicopters beginning with ship #47. These modifications are expected to eliminate the problem of the roof collapsing into the occupiable area in HU-1B helicopters; however, this potentially dangerous situation still exists in all HU-1A helicopters in the system. A solution to this problem would be the acceptance of the second approach submitted in the Bell study under RFA #12 involving the addition of roll-over structure to prevent the roof from collapsing down onto the seat backs.

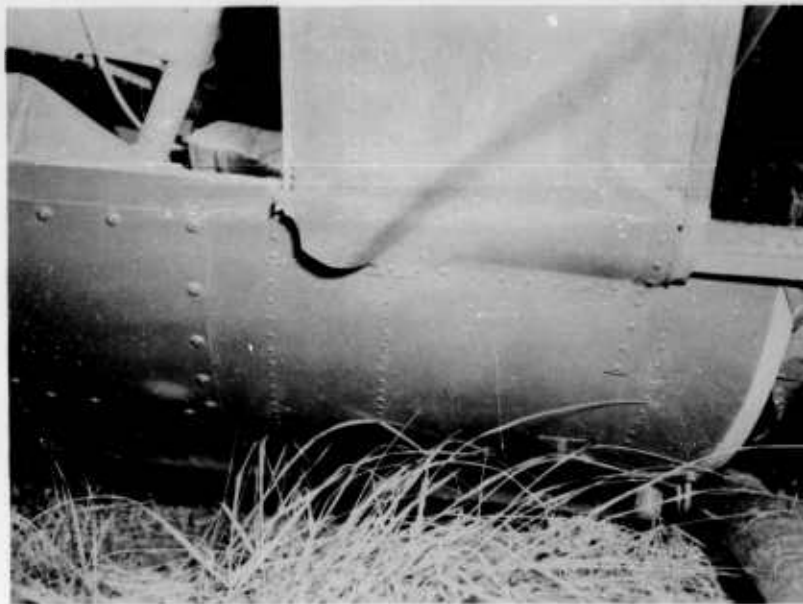
Figure 11. Side view showing distortion and impending separation of left vertical support at lower attachment.

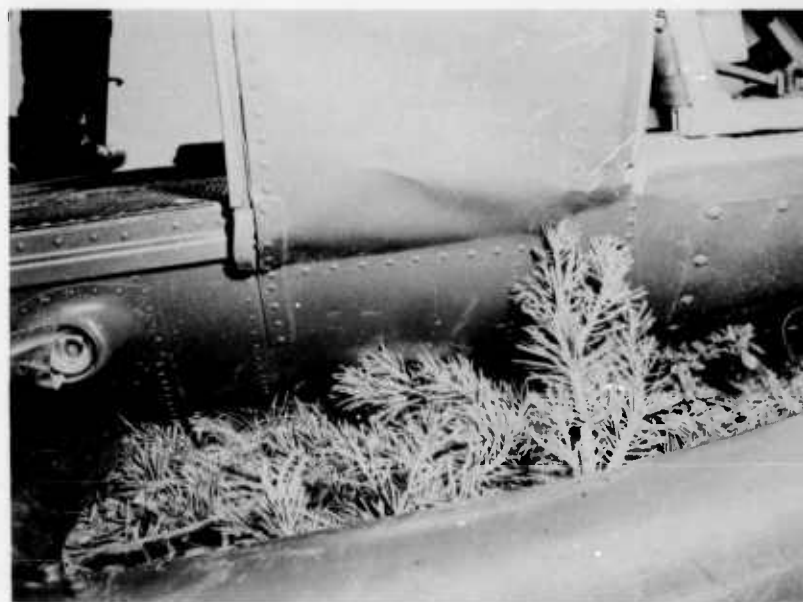
Figure 12. Side view showing distortion and impending separation of right vertical support at lower attachment.

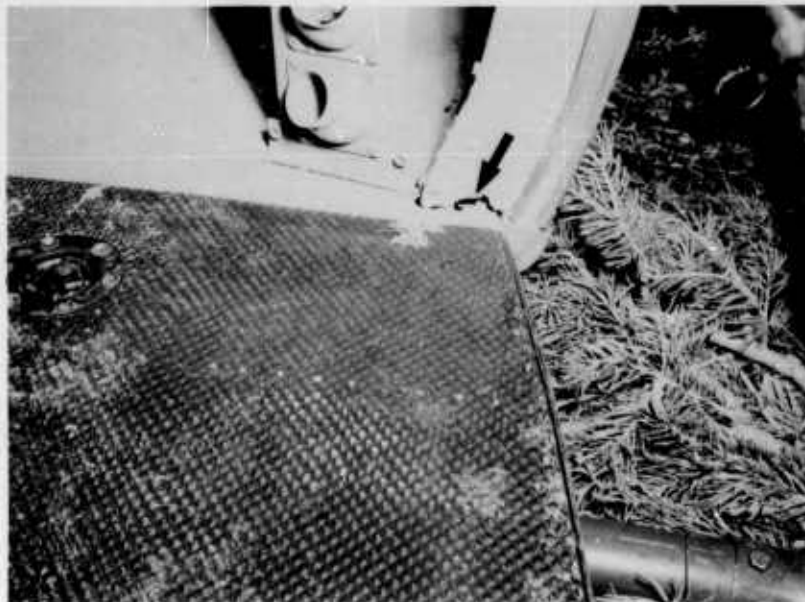
Figure 13. The arrow depicts the separation of the right vertical side support from its attaching point, floor level.

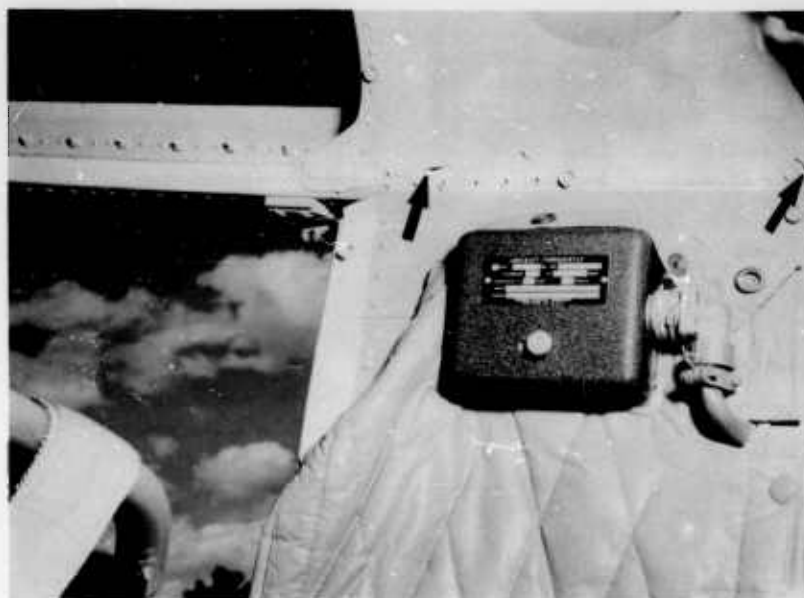
Figure 15. The arrows depicts the failures at the top of the right vertical side support.

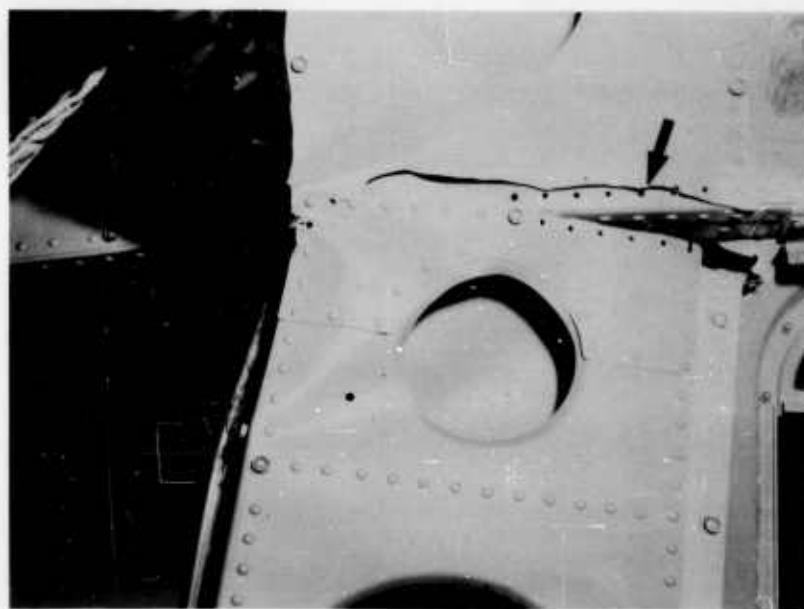
Figure 16. The separation of the left vertical side support and roof structure is denoted by the arrow.

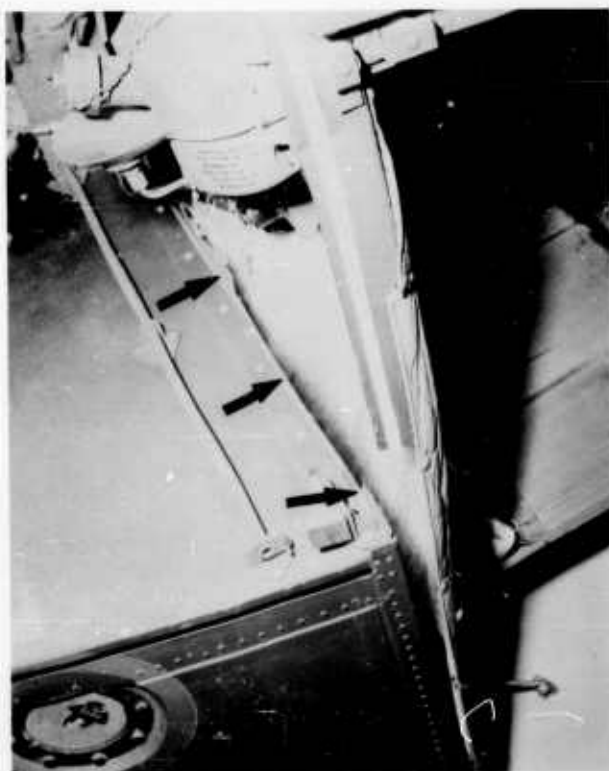
Figure 18. Rear view of the right side showing the firewall displacement (arrows). It should be noted that there was very little forward deceleration in this accident.

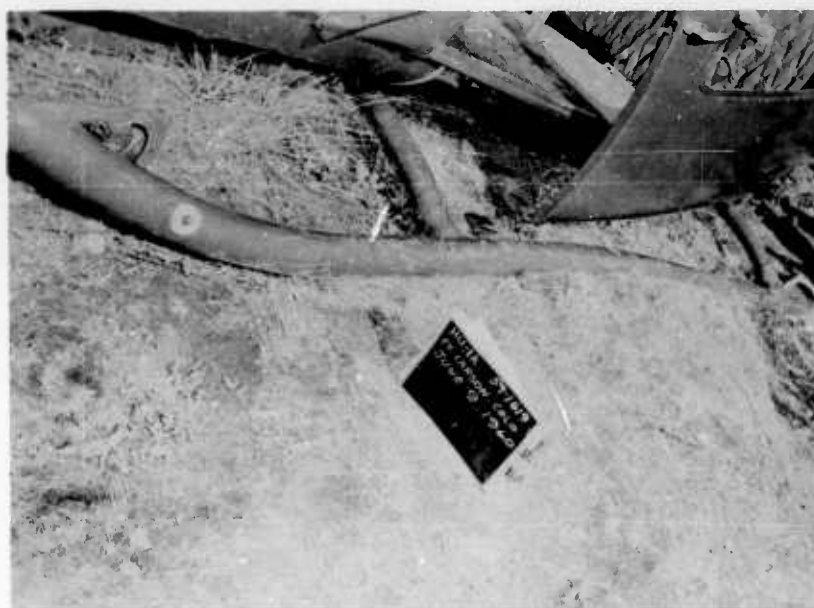
Figure 20. Note the manner in which the landing skid has deformed to fit the contour of the hill.

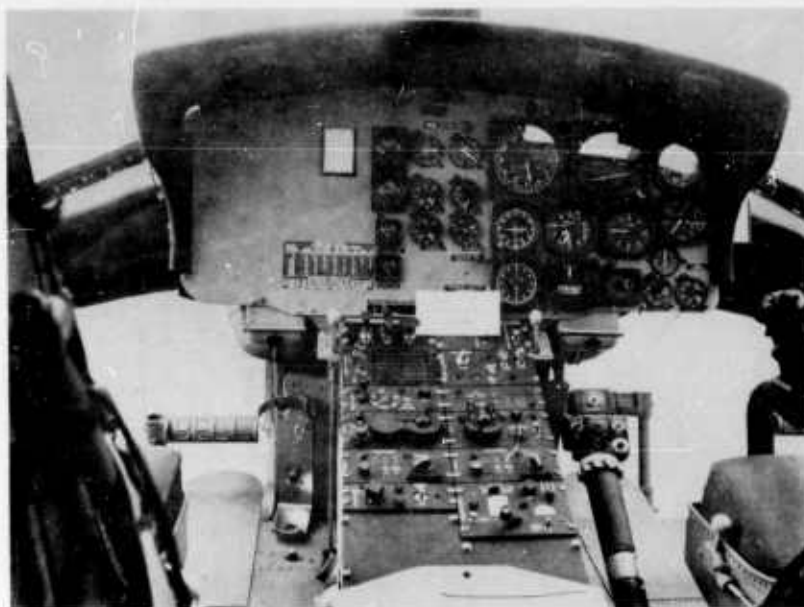
Relatively minor damage was experienced in the cockpit area during impact. The damage consisted primarily of a broken left windshield, broken plexiglas in both pedal wells and slight forward displacement of the instrument panel. The pilot and copilot seats remained intact and safety belts and shoulder harnesses were effective. Figure 21 illustrates the intact condition of the cockpit section.

Figure 21. The intactness of the cockpit is depicted in this photo. The fire extinguisher was removed after the accident.

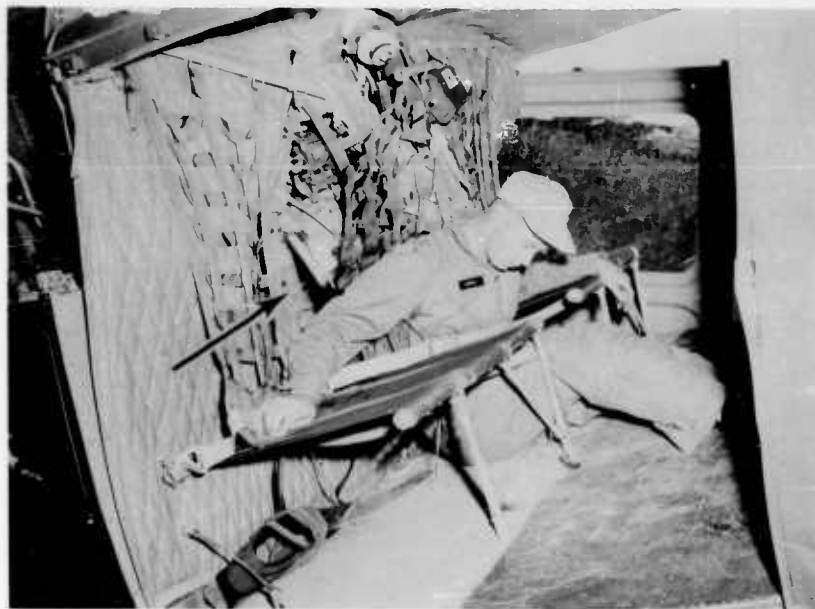
tube coupled with the extreme slack in the occupant's seat belt permitted him to move forward and downward, away from the transmission as shown in Figures 23 and 24. This fortunate coincidence probably prevented dangerous or fatal injuries to the occupant. Jagged and torn metal caused by penetration of the transmission is shown protruding into the cabin area in Figure 25.

Figure 23. Posed photograph from right side of aircraft shows final position of occupant and penetration of aft cabin bulkhead by transmission assembly (see arrow) and its relation to occupant.

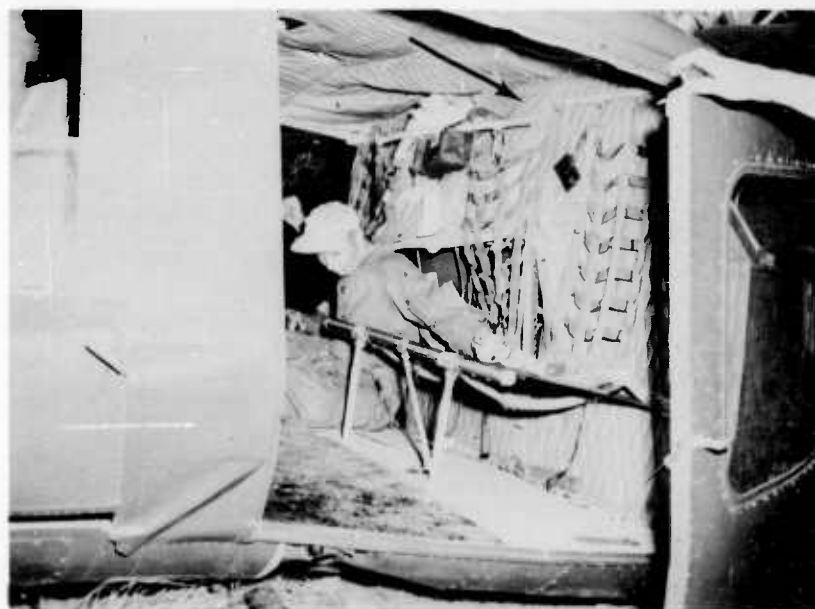
In addition to failure of the front seat support tube, the seat back upper attachment of seat R-1, which is attached to the firewall by means of four bolts inserted through drilled holes in the attachment, also failed, Figure 26. This attachment supports the seat back webbing. Failures frequently occur at these weakened points under relatively low crash forces. It appears that a clamp type attachment similar to that which supports the rear seat support beam in the HU-1A, would be more satisfactory. It is obvious that a considerable load was imposed on this support by the transmission failure; however, numerous failures of this type seat have been noted in other accidents in which the transmission was not a factor.

Figure 24. Posed photograph from left side of aircraft shows final position of occupant and broken seat back upper attachment (arrow).

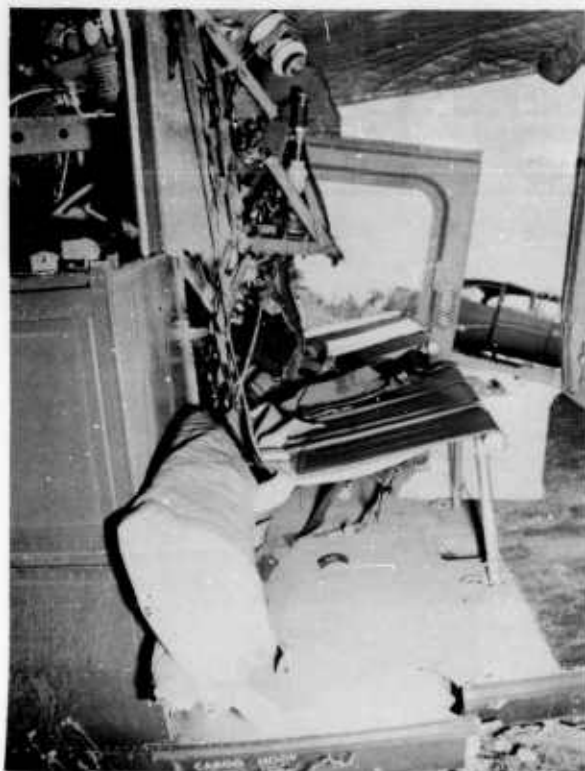
Figure 25. The 17-inch forward displacement of the transmission should be noted in this side view. The forward displacement of the firewall is also visible. The fracture in the floor occurred at the outboard edge.

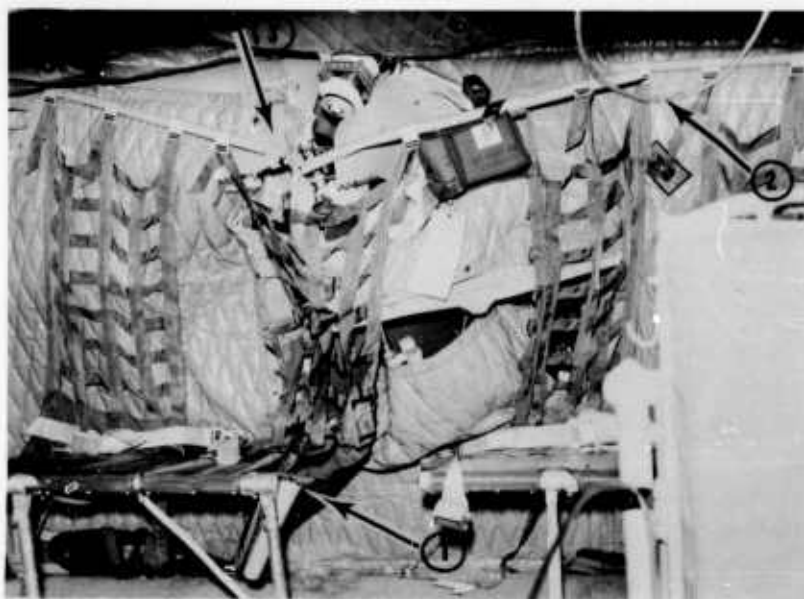
Figure 26. Arrow 1 depicts the broken front seat tube. This failure permitted the occupant to be thrown onto the cabin floor. Arrows 2 and 3 point out the fractures in the seat back upper attachment.

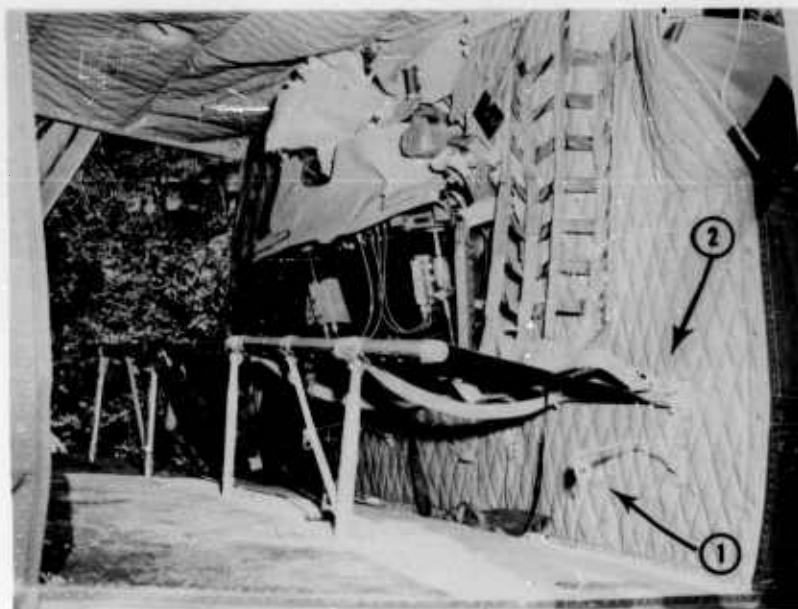
Figure 27. Arrow 1 denotes the desirable safety belt attachment. Arrow 2 depicts the manner of attachment which is normally utilized.

An additional item of interest is depicted in Figure 27. Arrow 1 points out a short length of cable which is anchored to primary structure. These cables are installed at intervals across the aft bulkhead and are intended to serve a two-fold purpose: (1) to anchor the ferry tank when utilized and; (2) to function as a safety belt attachment when transporting troops. The utilization of these cables relieves the rear seat support beam of a considerable load and also properly positions the safety belt across the hips at approximately a 45° angle. This desirable 45° angle places a majority of the load on the hips and forces the spine to flex at the lumbosacral joint. When the safety belt is attached to the "O" ring as shown in Figure 27, Arrow 2, the safety belt crosses the occupant at approximately a 90° angle and forces the spine to flex in a higher area, often causing flexion fractures. It is therefore suggested that all safety belts in the cabin be attached to the cables to afford the occupant maximum protection.*
